# Manhole Inspection Summary

Manhole # S43Y1\_011MH

Insp Date: **1/26/09 3:29 PM**

**Location** Address: **3437 9th St.**

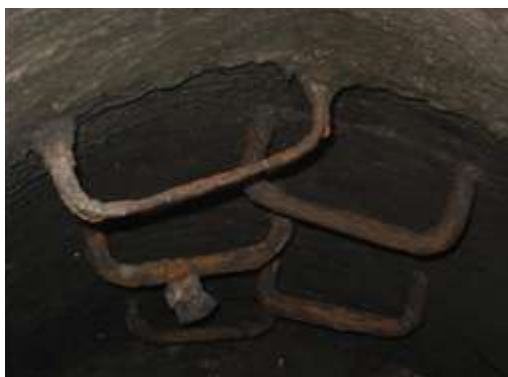
Steps

**Steps** Count: **5** Missing: **0** ☒ **Corroded**

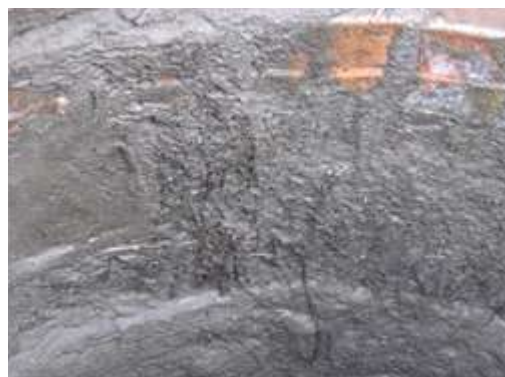
Defect 2

Infiltration: ☐ None ☒ **Joint** ☐ Cracks ☐ Mortar ☐ Roots ☐ Wall

Infiltration through Joint

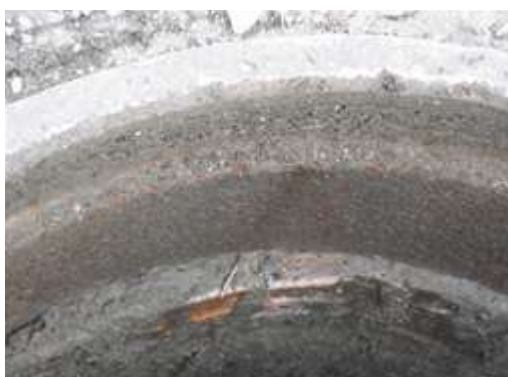
Defect 1

**Frame** Offset: **1** (in.) Condition: ☒ Sound ☐ Cracked ☐ Leaks

Frame offset

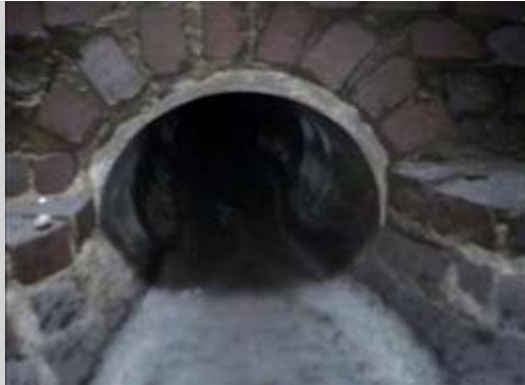
12 O'Clock Outflow

15 in. Circular Gravity Sewer  
Pipe Out @ 12 O'Clock

Pipe Height: **16.8** (in.) Rod and Bar (Angled)  
Pipe Material: **Clay** ☐ Pipe Lined  
Invert Depth: **11.14** (ft.) Flow Characteristics: **Fast**  
Deposits: ☒ None ☐ Mud ☐ Sludge ☐ Debris ☐ Grease  
Silt Depth: (in.) Deposits Extent:  
Infiltration: **None** Pipe Seal Cond: **Sound**

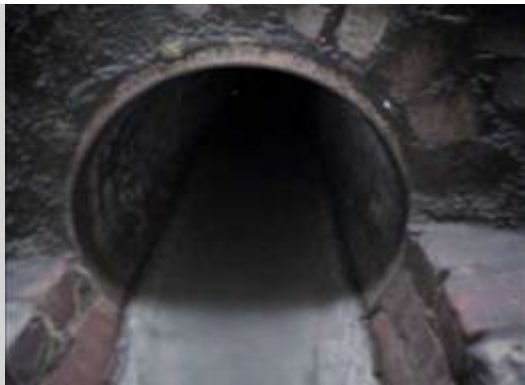
6 O'Clock Inflow

15 in. Circular Gravity Sewer  
Pipe In @ 6 O'Clock

Pipe Height: **15.6** (in.) Rod and Bar (Angled)  
Pipe Material: **Clay** ☐ Pipe Lined  
Invert Depth: **10.70** (ft.) Flow Characteristics: **Fast**  
Deposits: ☒ None ☐ Mud ☐ Sludge ☐ Debris ☐ Grease  
Silt Depth: (in.) Deposits Extent:  
Infiltration: **None** Pipe Seal Cond: **Sound**
